SCIENTIFIC REPORTS

Sediment replenishment combined with an artificial flood improves river habitats downstream of a dam

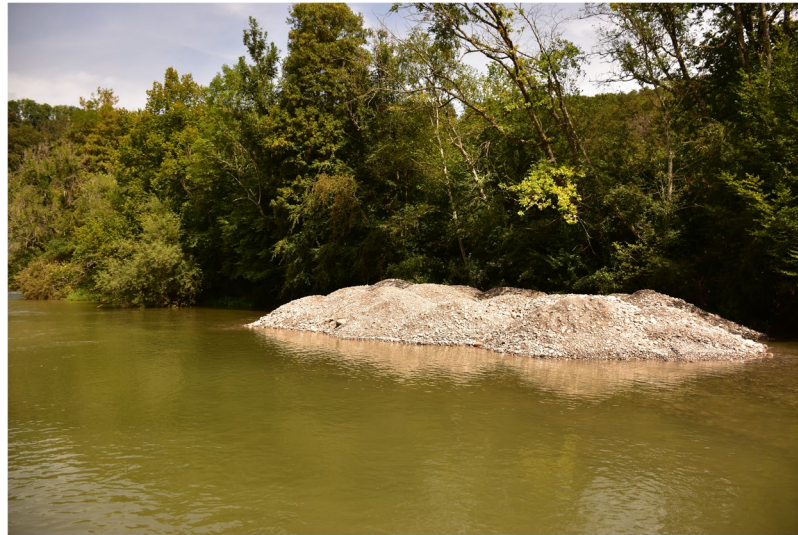
Figure 2. Deposit I in the river before the flood experiment. Its dimensions correspond to ca. $22 \times 8 \times 1.5 \text{ m}^3$ (length, width, height). The material was excavated from the adjacent riparian forest. Image © Elena Battisacco.

Sediment erosion and deposition after the passage of the artificial flood. To follow the movement of the replenished material, 489 stones with a mean diameter of 5.7 cm (corresponding to d_m) and 11.3 cm (corresponding to d_{90}) were equipped with RFID PIT tags and added to each deposit (Fig. 2, see *Methods* for more details). The passage of the two-year flood was not strong enough to erode all the deposits (Fig. 3a). In deposits I, II and IV, sediment was mainly eroded laterally, whereas deposit III was fully eroded.

In addition to the flood pulse, four sediment deposits were added to the river 9 km downstream of the dam (coordinates 46°45′29.21″N, 7°06′11.47″E; Fig. 1a) with a total volume of 1000 m³ (Fig. 2). The deposit lengths as well as the distance between deposits on the same river bank were slightly less than the river width (around 22 m, Fig. 1b). The mid-channel distance available for flow, in between deposits, was roughly half of the river width. The replenished material was excavated from the adjacent alluvial forest on the right bank of the river. The grain size distribution of the excavated material was determined analyzing 21 samples for pebble counts²³ and photo sieving using BASEGRAIN²⁴. The characteristic grain sizes were determined as d_{50} = 3.9 cm, d_{65} = 5.3 cm, d_m = 5.7 cm, d_{84} = 8.7 cm and d_{90} = 11.3 cm.

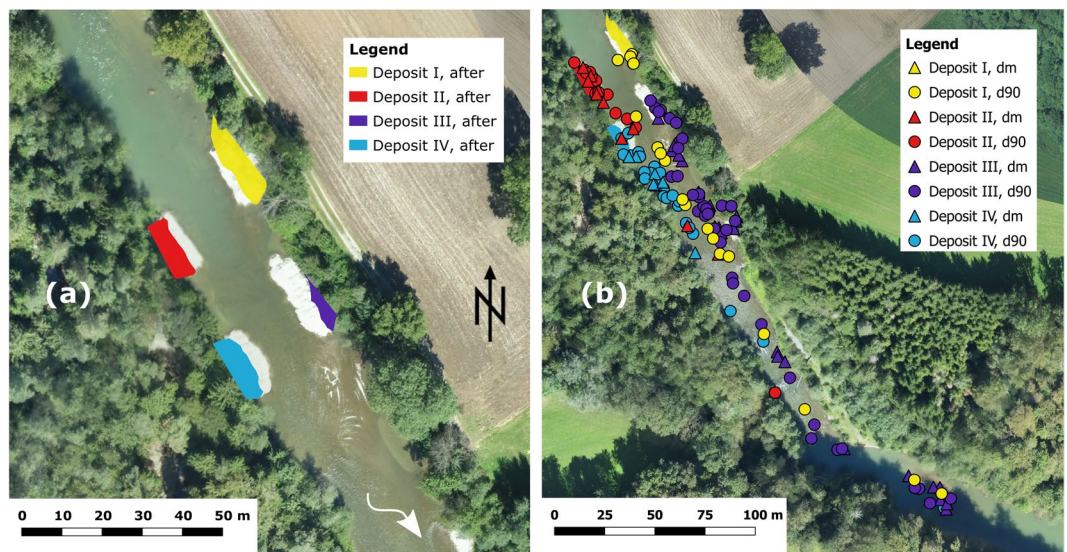
Figure 3. (a) The exposed dry surface of the four deposits before (air-image background © Research unit Ecohydrology, ZHAW) and after (colored areas) the artificial flood event. The residual flow discharge was $3.5 \text{ m}^3/\text{s}$ when the air-image was taken before the flood event and $2.5 \text{ m}^3/\text{s}$ when the dry surface was measured after the flood event. (b) RFID PIT tag equipped sediments detected after the flood event (background © Research unit Ecohydrology, ZHAW).

During surveys made after the artificial flood, 277 (57%) RFID PIT tagged sediments were recovered (Fig. 3b, see *Methods* for details about the detection). A total of 111 tags were detected on the remaining part of the deposits which was not eroded and 166 tagged sediments were eroded and transported downstream. The travelled distance depended mainly on the deposit of origin of the sediment and was always <286 m. On average, sediments with the size corresponding to the d_m travelled about 100 m and the sediments with the size corresponding to d_{90} about 65 m (Fig. 4a). However, their maximum transported distance is equivalent. Tagged stones from the deposit I and III were further transported than tags from deposit II and IV (Fig. 4b). Most of the detected tagged stones had deposit III as origin, followed by deposit I, IV and II. Tagged sediments from deposit I and III were all detected on the left side of the river, whereas the inverse was observed for sediments originating in deposits II and IV (Fig. 3b). The equipped tags settled in clusters, similar to the previous laboratory observations.

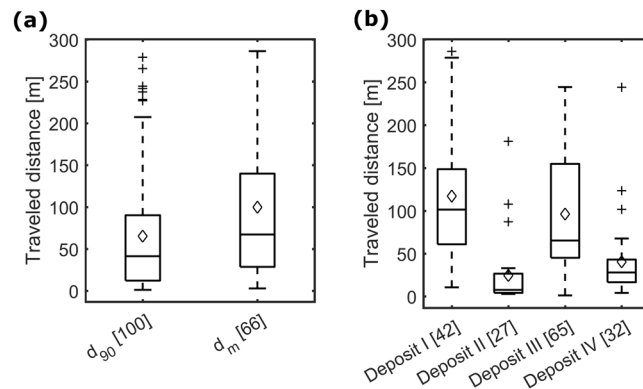
Figure 4. Traveled distances of the RFID PIT tagged sediments which were detected with the mobile antenna after the flood event sorted by (a) size and by (b) deposit of origin (see *Methods for following sediment transport* for details about the detection).
